ALABAMA DEPARTMENT OF TRANSPORTATION

Annual Inspection Report Bessemer Municipal Airport

ANNUAL INSPECTION REPORT

BESSEMER MUNICIPAL AIRPORT BESSEMER, ALABAMA

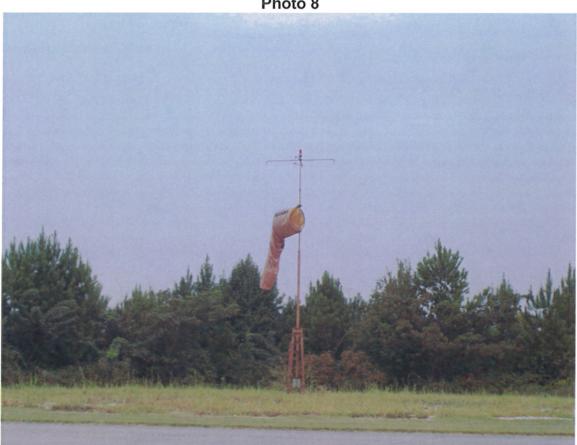
Photo 8

→ The wind direction indicator was inspected and found to be lit and operational.

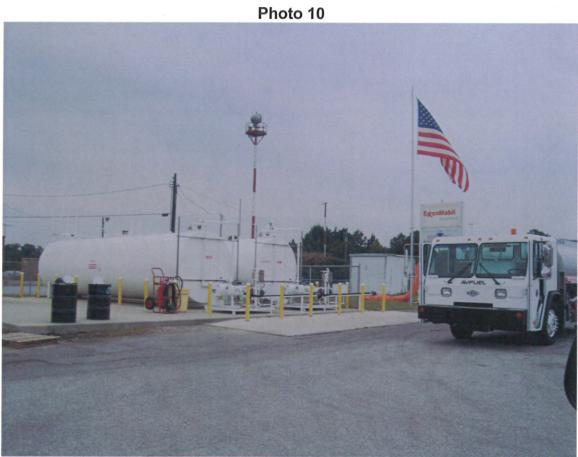
Fueling Area

The fueling area meets the requirements established by the Alabama Department of Transportation. However the State of Alabama Department of Agriculture and Industries may have additional requirements for fueling systems that were not considered during this inspection.

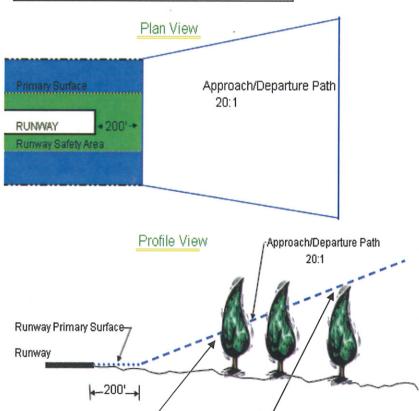
APPENDIX 1

Approach and Departure Path Dimensions				
Inner	Outer			
Width	Width	Length	Acreage	
250 Feet	450 Feet	1,000 Feet	8.04 Acres	
Primary Surface Dimensions				
250 Feet Wide Centered Along Runway Centerline				
Extending 200 Feet Past the Runway End				
Runway Safety Area Dimensions				
120 Feet Wide Centered Along Runway Centerline				
Extending 200 Feet Past the Runway End

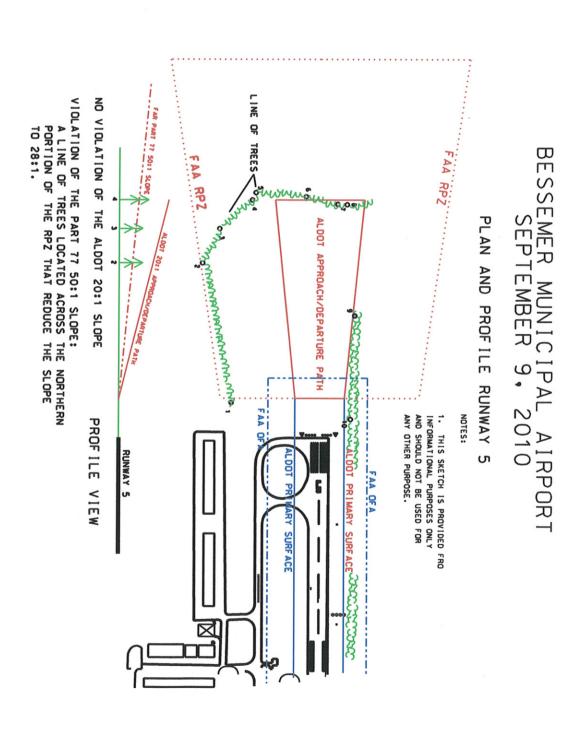
VIOLATIONS OF THE 34:1 SLOPE
